Sidakah Home Inspections LLC

Your Property Inspection Report

111 AnyStreet Lane, Guyton, 31312

Inspection prepared for: Bob Smith
Date of Inspection: 4/11/2017 Time: 9AM

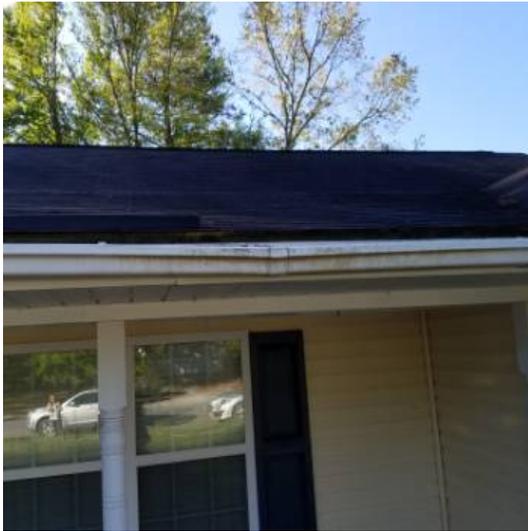
Figure 1.1 DEFECT Gutter sagging from apparent debris accumulation.

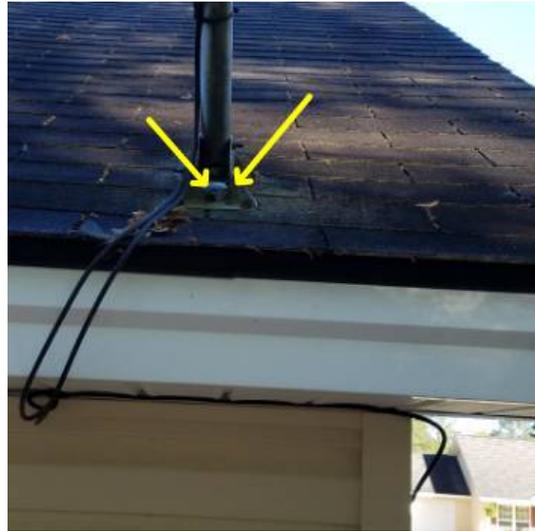
Figure 1.2 DEFECT Possible moisture intrusion point. No sealing measures taken in mounting of satellite dish. Consult roofing contractor for repair.

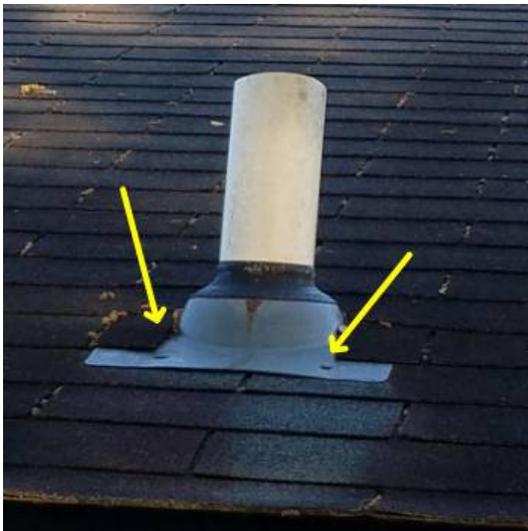
Figure 1.3 DEFECT Nails in flashing exposed. Possible water intrusion point. Condition on all vent pipes on roof. Consult roofing contractor for repair.

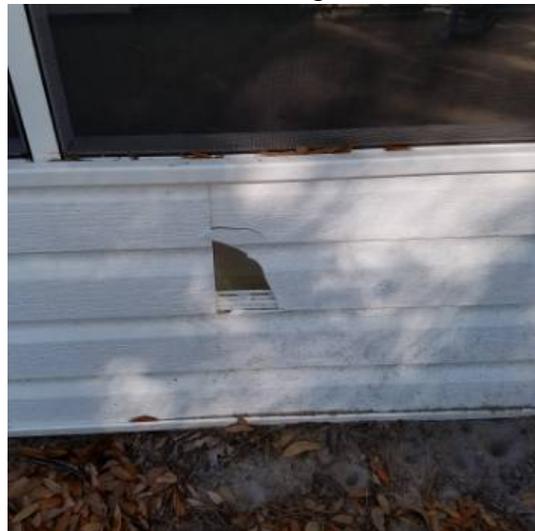
Figure 1.4 DEFECT Broken siding on rear of house.

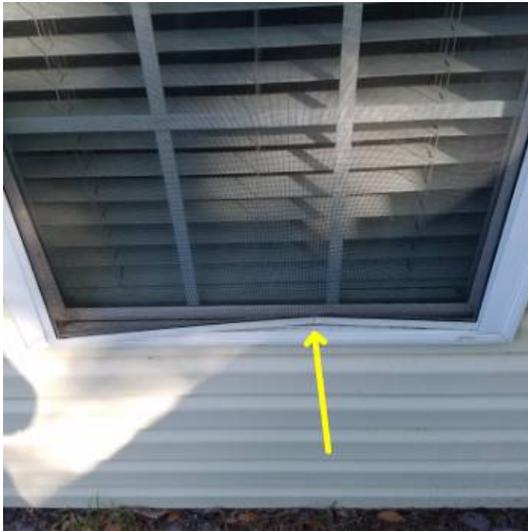
Figure 1.5 DEFECT Damaged Screen.

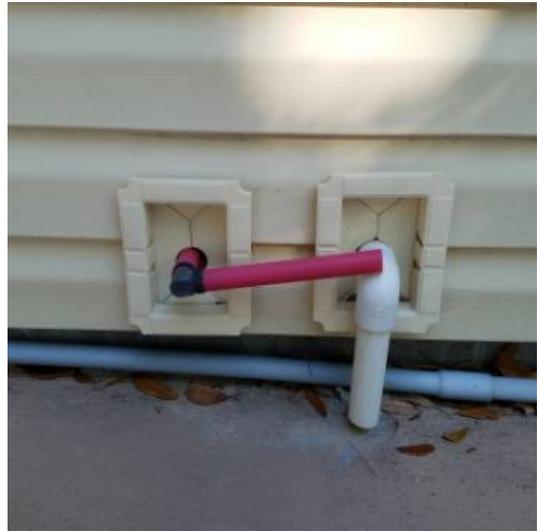
Figure 1.6 DEFECT Drain pipe not running downhill. Standing water left in line could create clog and cause drain to malfunction. Consult plumbing contractor for issue correction.

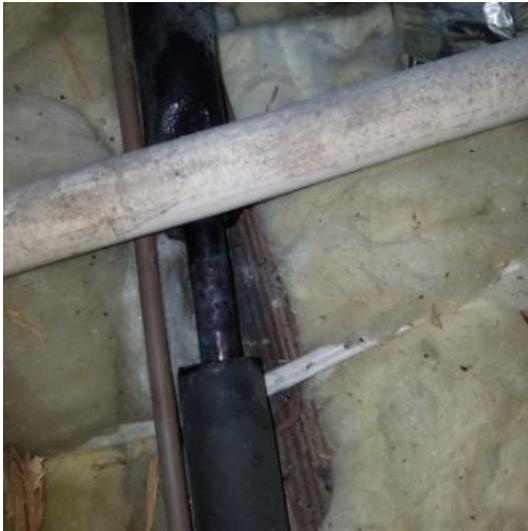
Figure 2.3.1 Insulation on Low Pressure refrigerant line in attic causing moisture in attic to condense into a liquid and falling on Ceiling joists. This can over time cause a mold issue as well as drywall damage if not corrected. Recommend Contacting HVAC Service Technician for repairs. if not corrected.

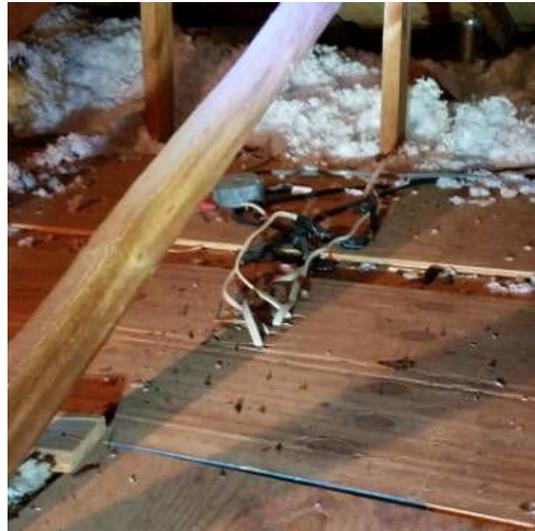
Electric, Heat, Water Heater		
Page 7 Item: 1	Electrical Panel	<ul style="list-style-type: none"> • Electrical Service Mast bent at roof protrusion. Bent mast pipe can damage service entrance conductors causing a failure of electrical service. Contact Electrical Service Technician for repairs. • Spliced & taped wires. See Figure 2.3.2

Figure 2.3.2 DEFECT Improper joining of Electrical conductors in attic. Recommend Contact qualified electrical service technician for assessment and repair.

- **Electrical Service Mast bent at roof protrusion. Bent mast pipe can damage service entrance conductors causing a failure of electrical service. Contact Electrical Service Technician for repairs.**
- **Spliced & taped wires. See Figure 2.3.2**

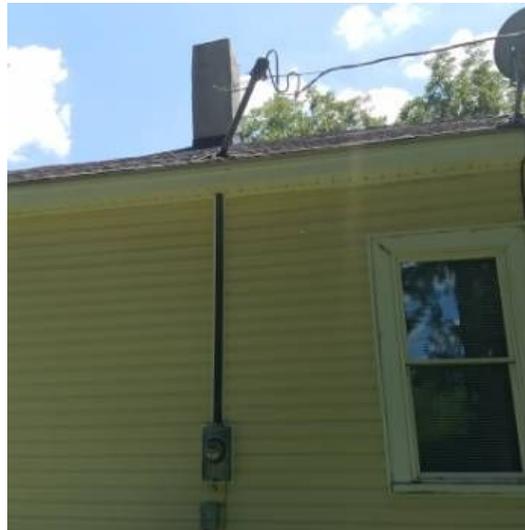
Figure 3.1.1 Electrical Service Mast bent at roof protrusion. Bent mast pipe can damage service entrance conductors causing a failure of electrical service. Contact Electrical Service Technician for repairs.

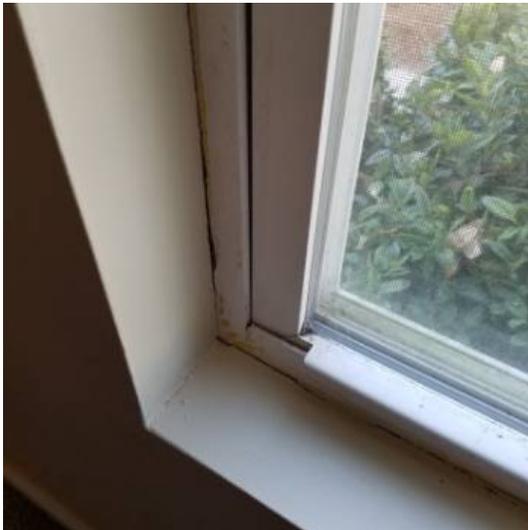
Figure 2.1 DEFECT Caulking broken around window.

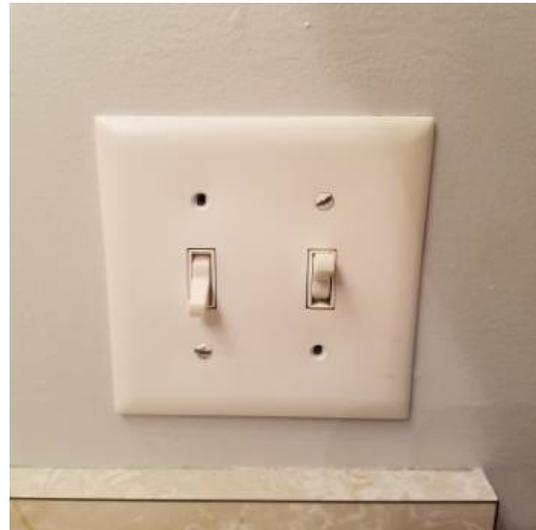
Figure 2.2 DEFECT Screws missing in switch plate in master bath.

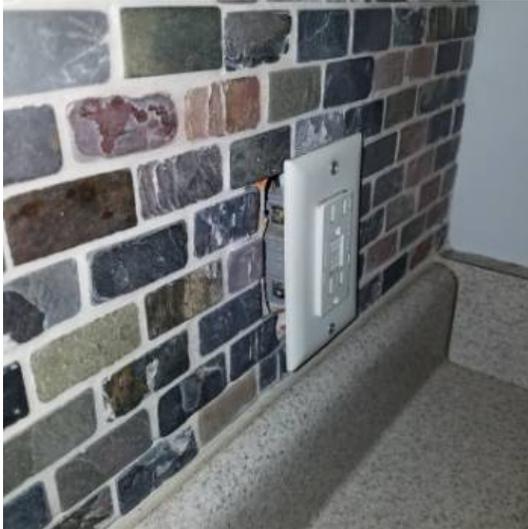
Figure 2.3 DEFECT Outlet/plate not secured to wall. Consult Electrician for repairs. Loosely mounted receptacles can move side to side causing ground fault.

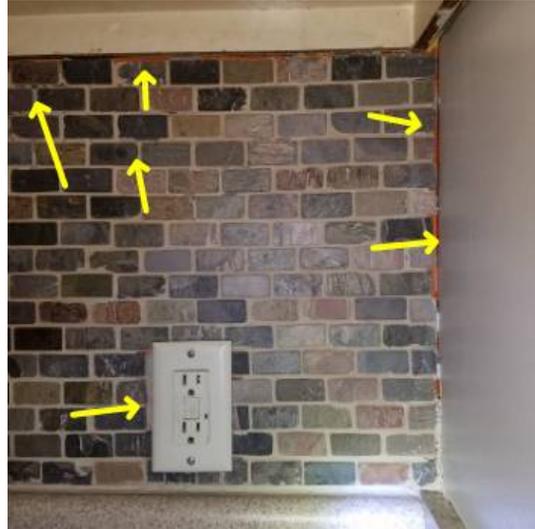
Figure 2.4 DEFECT Grout/tile work incomplete. Consult masonry contractor for work completion.

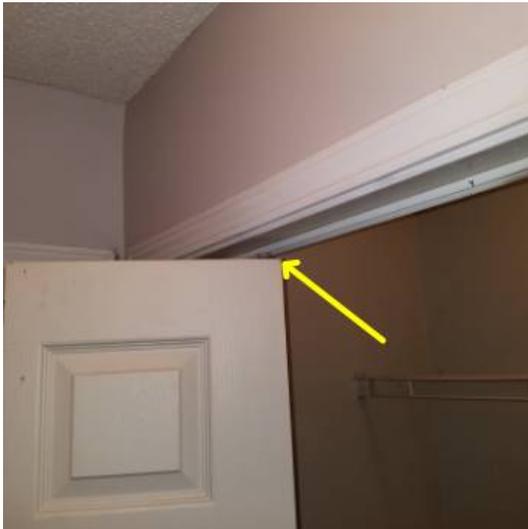
Figure 2.5 DEFECT Bifold doors not in track.

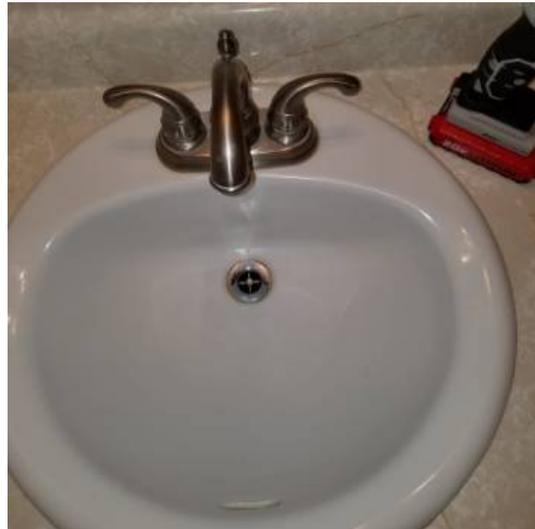
Figure 2.6 DEFECT Stopper broken in Guest bath sink. Consult plumber for repair.

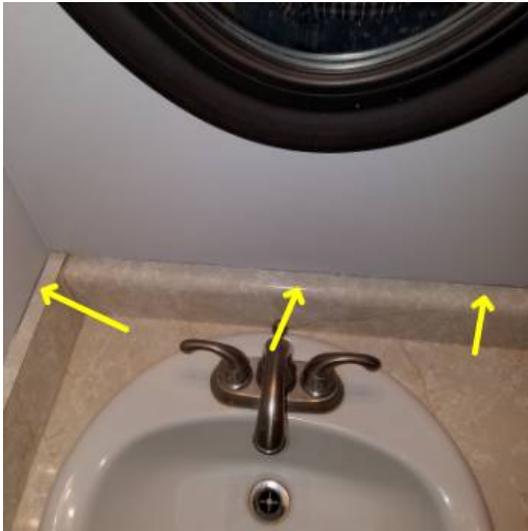
Figure 2.7 DEFECT Caulking broken around guest bath vanity.

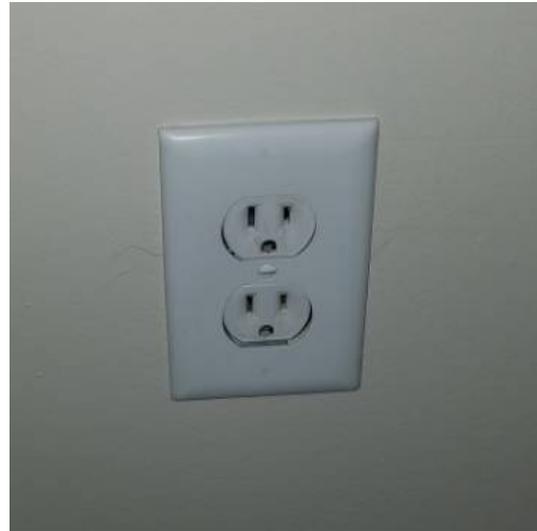
Figure 2.8 DEFECT Guest bedroom outlet not properly secured in guest bedroom facing front side of house. Consult Electrician for repair estimates.

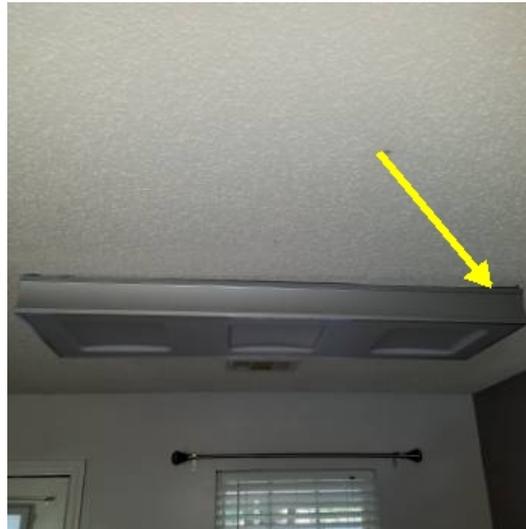
Figure 2.9 Light fixture apparently sagging posing possibility of part or all of the fixture falling. Consult with electrician to have re-mounted properly.
